UNITED STATES ENVIRONMENTAL PROTECTION AGENCY

SUBJECT: Inspection Report Transmittal to Ledgeview Farms, LLC

On April 9, 2015, EPA conducted an inspection of your facility, Ledgeview Farms in De Pere, Wisconsin. The purpose of the inspection was to evaluate compliance with the Clean Water Act (CWA) and Administrative Order V-W-13-AO-22. Ledgeview Farms is a large Concentrated Animal Feeding Operation (CAFO) as defined in 40 C.F.R. § 122. During the inspection, we observed violations of the CWA and Administrative Order. The CWA and Order requires you to immediately cease all unauthorized discharges.

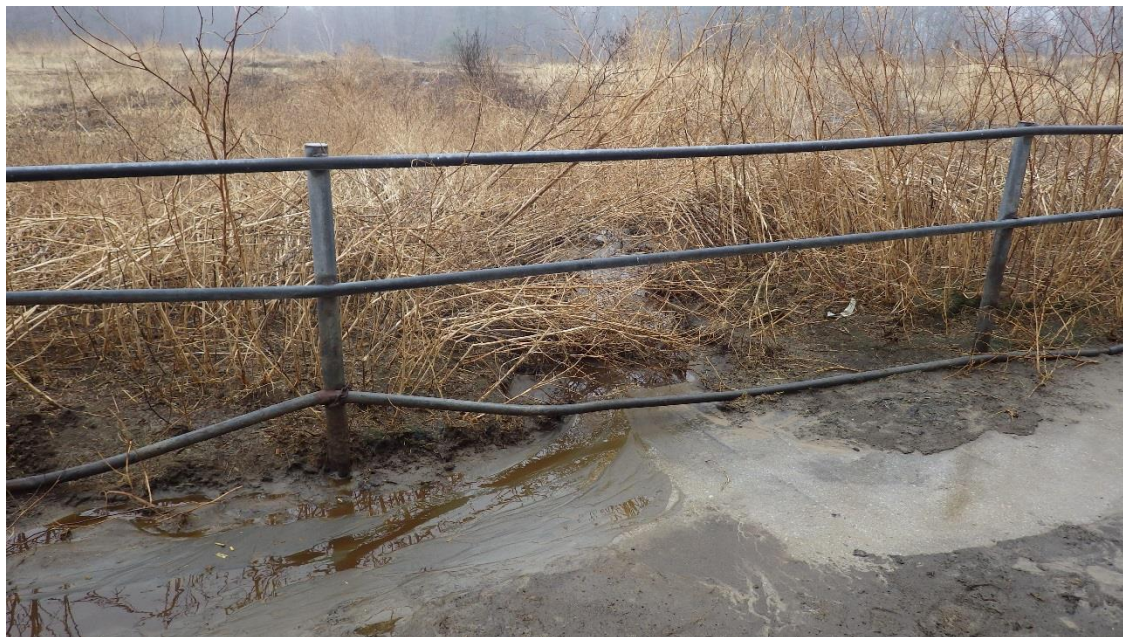
3: RIMG0011

Description: Manure and process wastewater flowed out of the northwest end of the Milk Cow Barn and from the access ways and silage bunker to the west of the Milk Cow Barn. The manure and process waste water flowed north and entered the field to the north of the Milk Cow Barn.

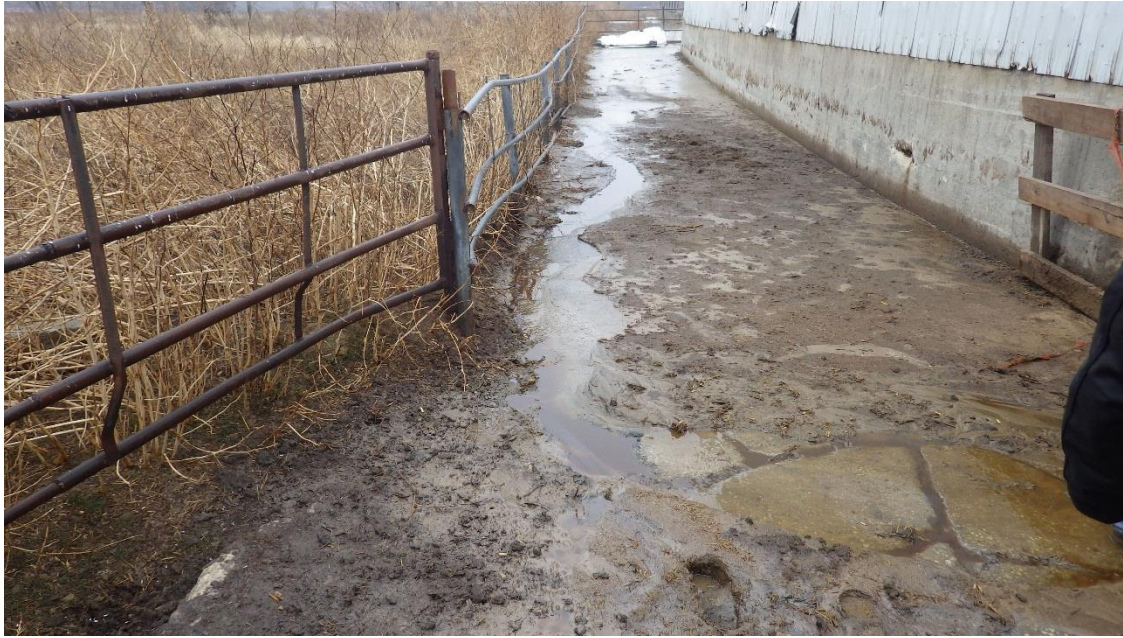
4: RIMG0012

Description: The manure and process waste water flowed north and entered the field to the north of the Milk Cow Barn. The accumulation of manure, bedding, and feed solids was observed through the field north of the Milk Cow Barn.

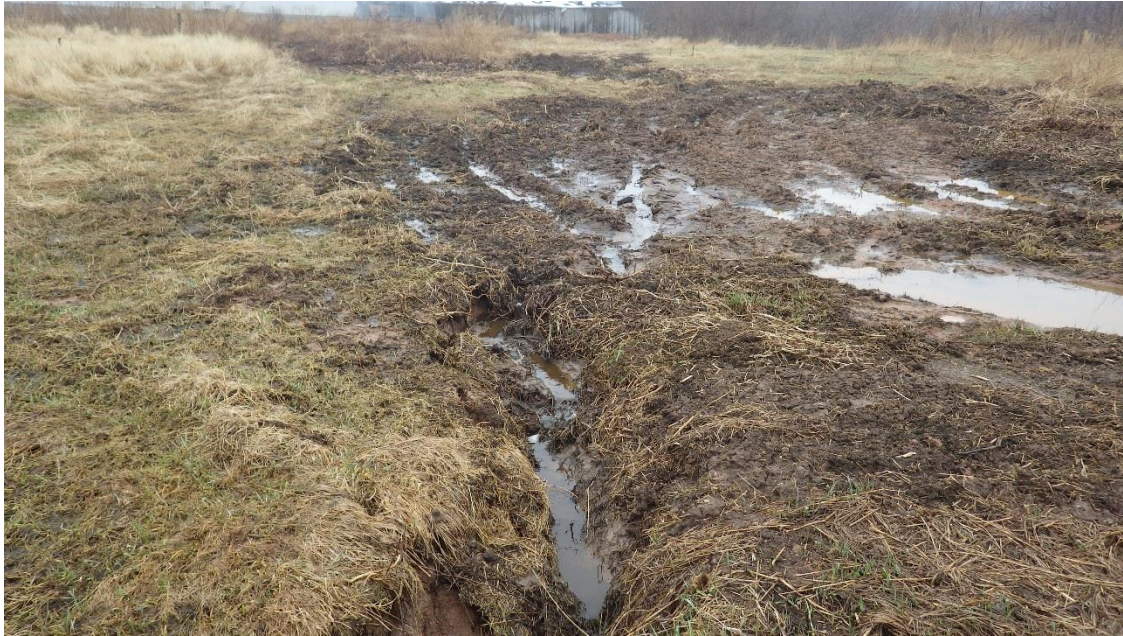
Description: Feed, bedding, and manure solids were observed throughout the field north of the Milk Cow Barn. The field sloped to the north.

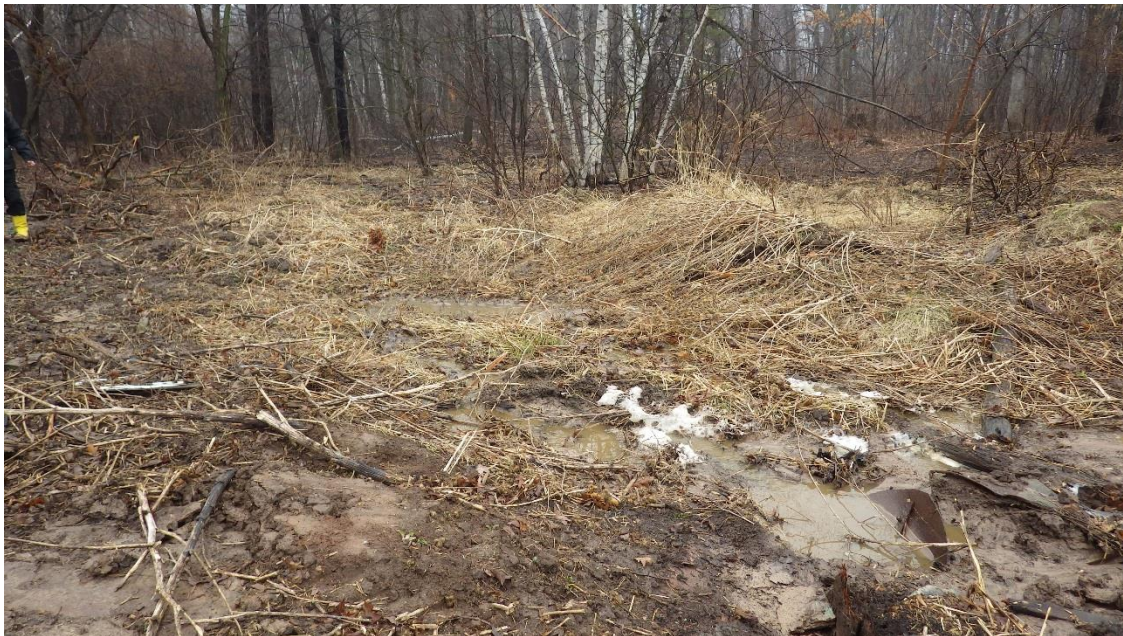
Description: The process wastewater pathway flows to the north through the borrow area north of the Milk Cow Barn. The topography of the disturbed field is sloped such that the flow continues north into a wooded area. There were no sediment and erosion controls to reduce the amount of sediment transferred off site.

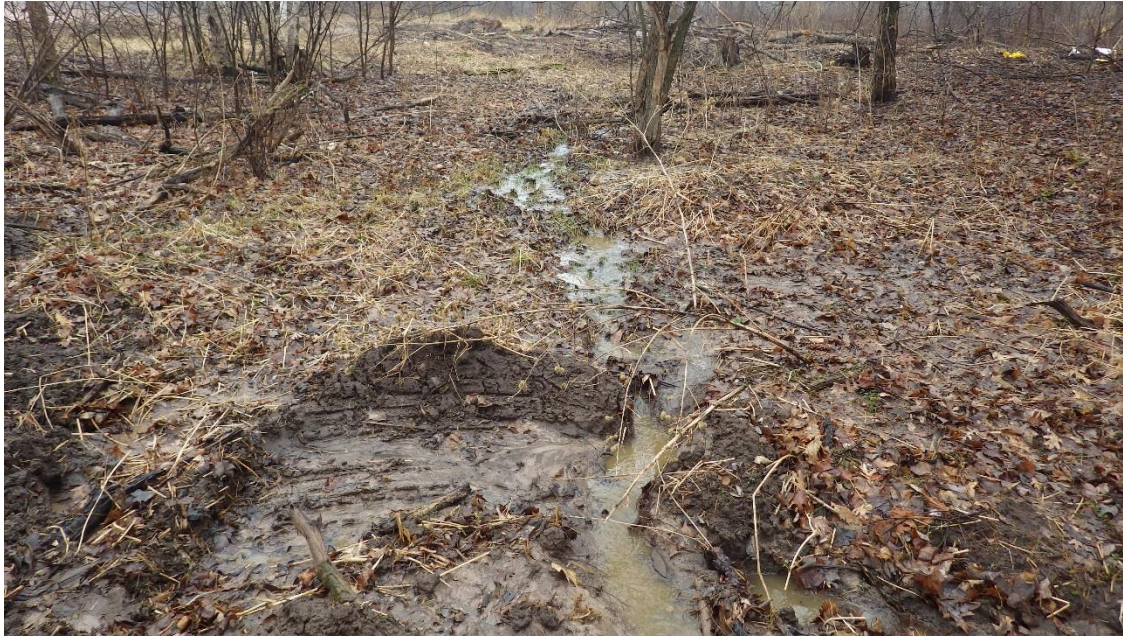
22: RIMG0031

Description: The process wastewater pathway flows to the north through a wooded area. Foam was observed in multiple locations throughout the pathway.

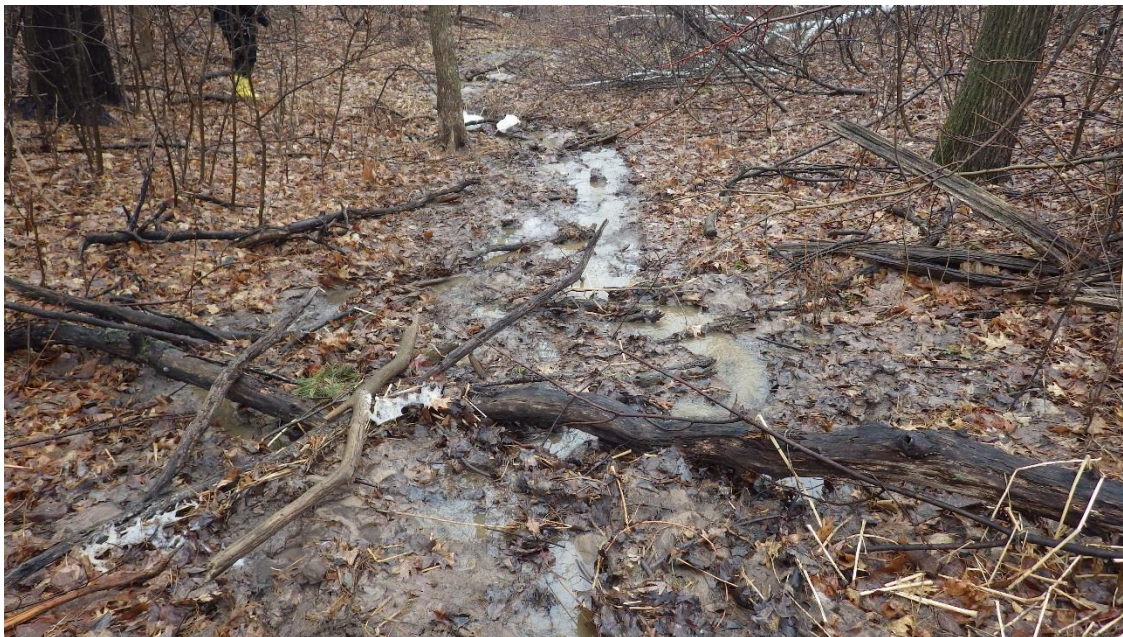
23: RIMG0032

Description: The process wastewater pathway flows to the north through a wooded area. Foam was observed in multiple locations throughout the pathway.

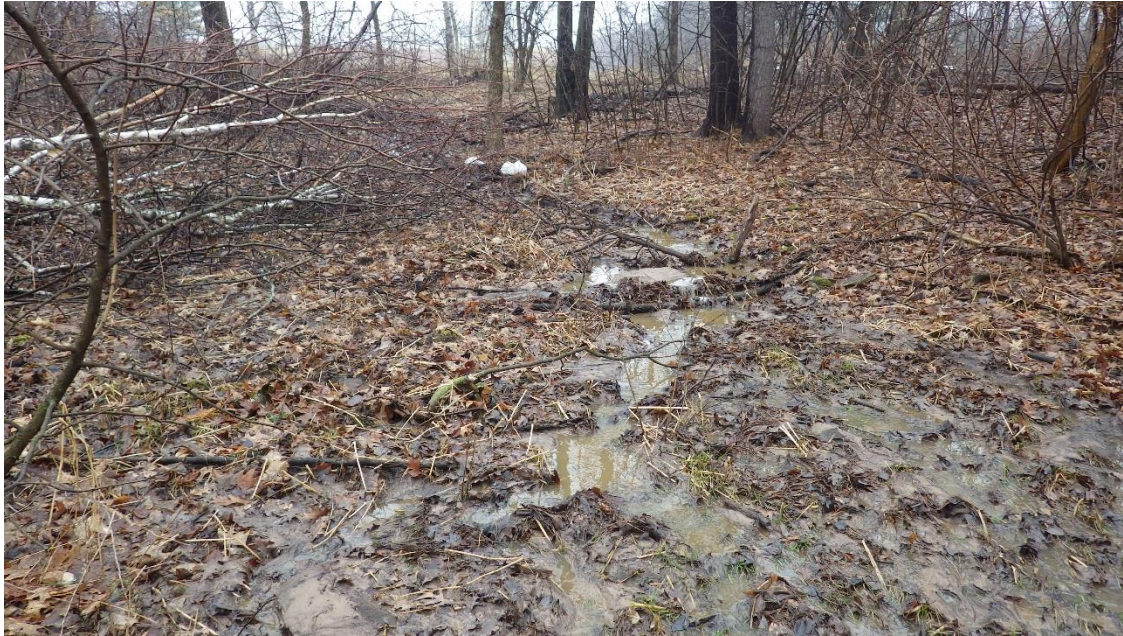
24: RIMG0033

Description: The process wastewater pathway flows to the north through a wooded area. Foam was observed in multiple locations throughout the pathway.

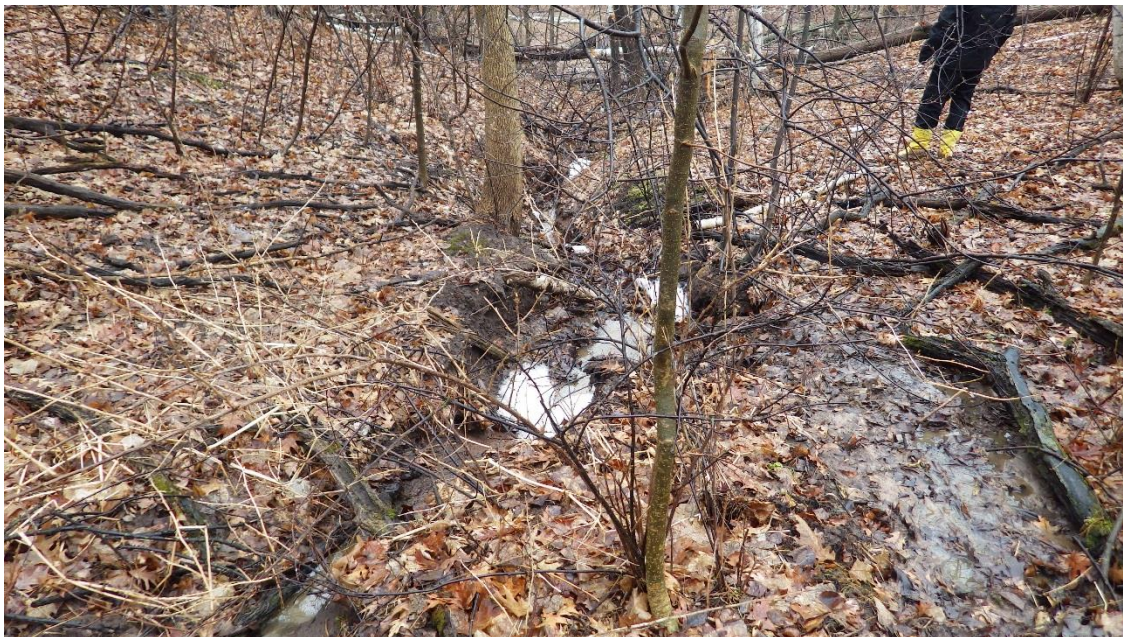
25: RIMG0034

Description: The process wastewater pathway flows to the north through a wooded area. Foam was observed in multiple locations throughout the pathway.

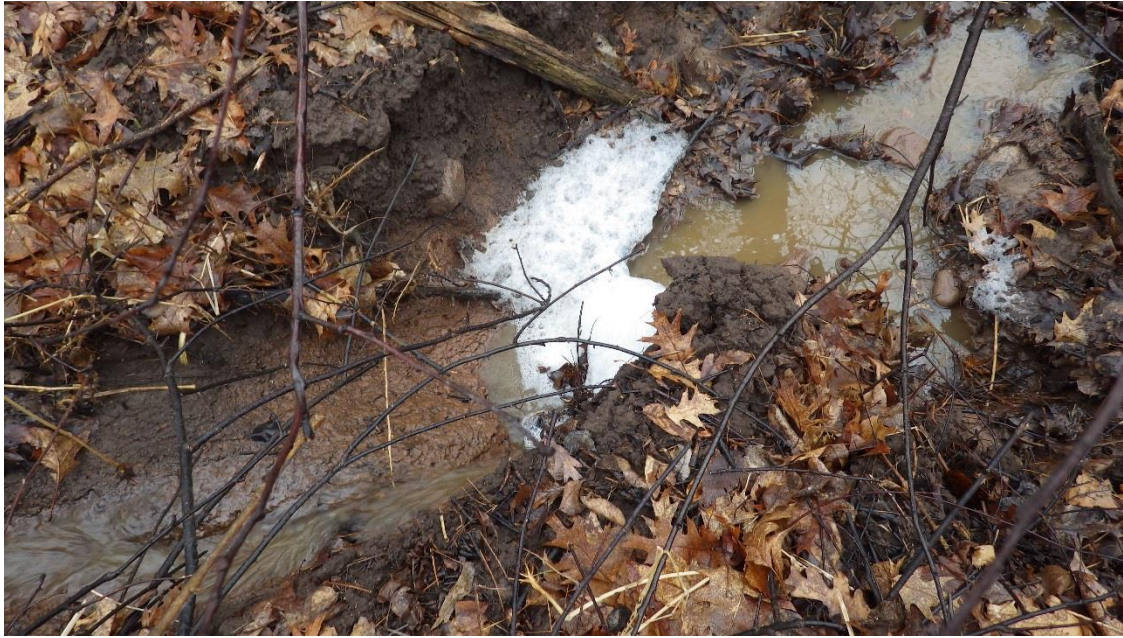
26: RIMG0035

Description: The process wastewater pathway flows to the north through a wooded area. Foam was observed in multiple locations throughout the pathway.

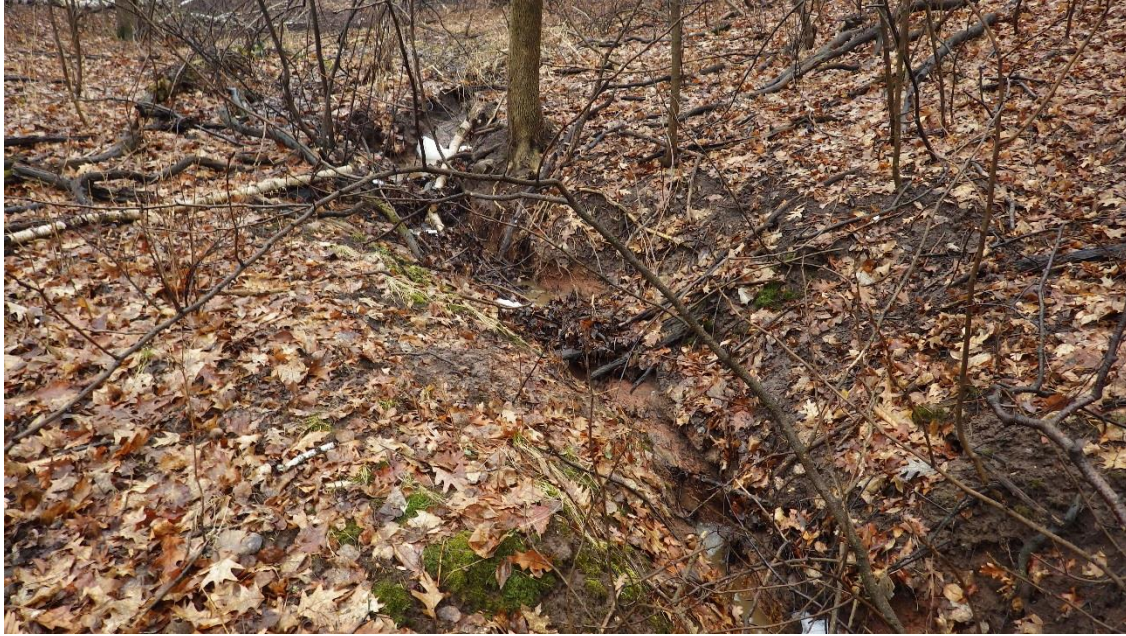
Description: The process wastewater pathway flows to the north through a wooded area. Foam was observed in multiple locations throughout the pathway.

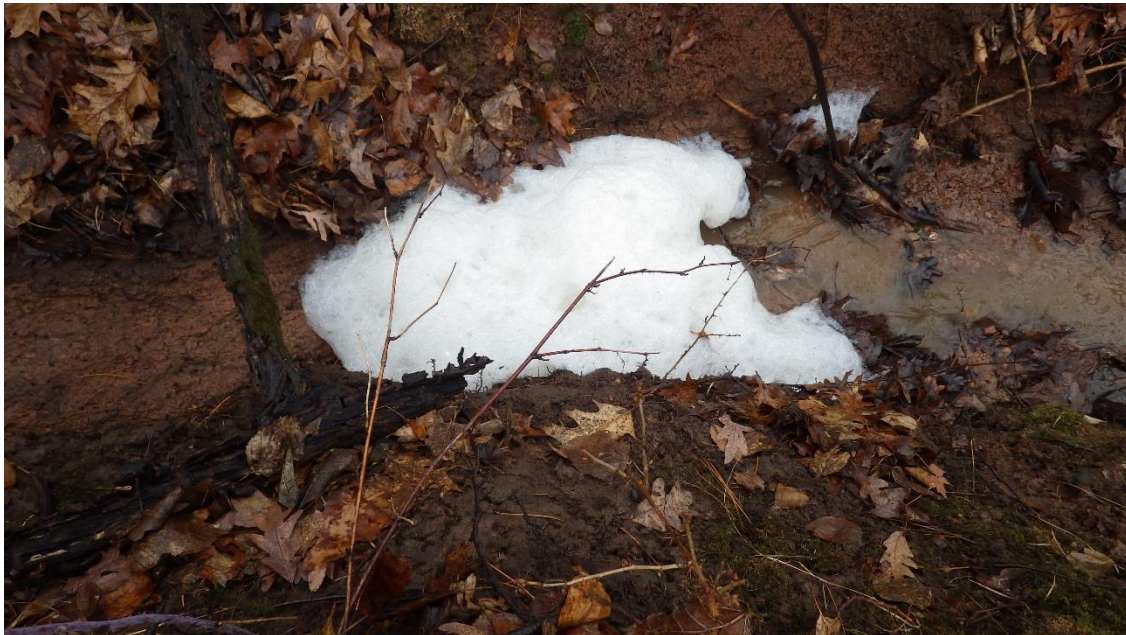
29: RIMG0038

Description: The process wastewater pathway flows to the north through a wooded area. Foam was observed in multiple locations throughout the pathway.

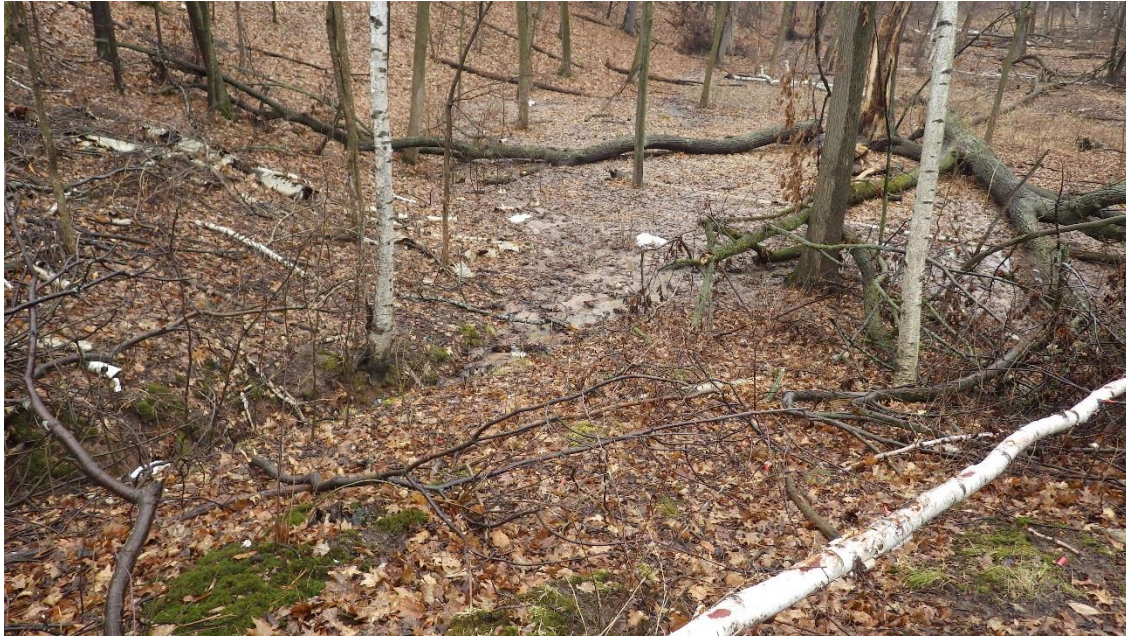
30: RIMG0039

Description: The process wastewater pathway flows to the north through a wooded area. Foam was observed in multiple locations throughout the pathway.

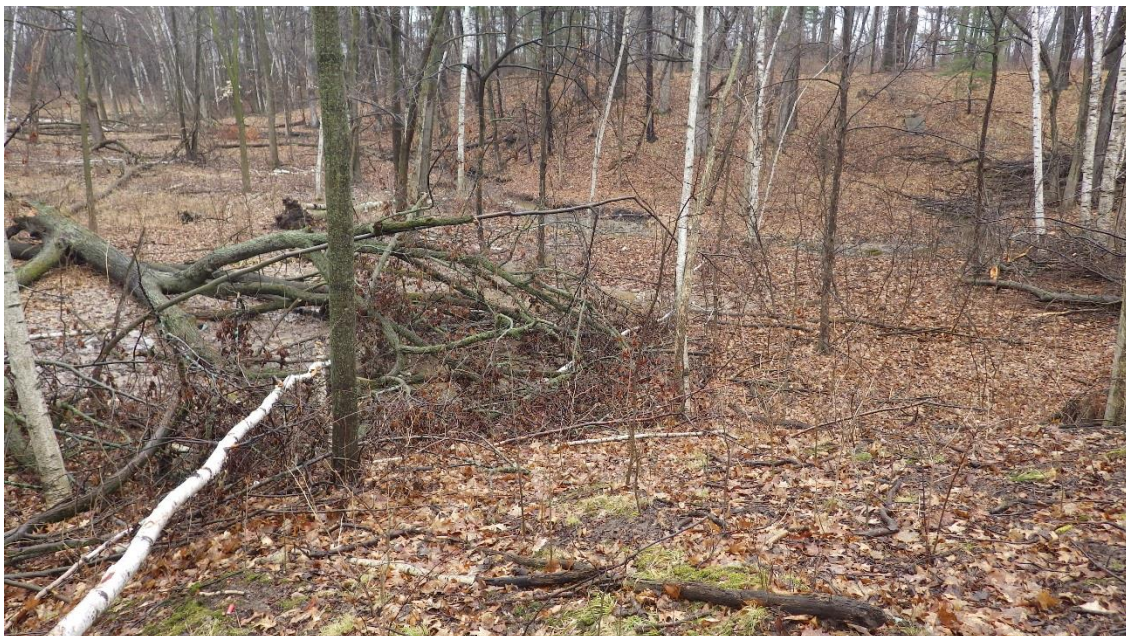
31: RIMG0040

Description: The process wastewater pathway flows to the north through a wooded area. Foam was observed in multiple locations throughout the pathway. After the flow pathway dropped down the ledge, it continued east through an area with relatively little elevation change to the unnamed tributary. Sediment deposition was observed throughout this area covering the forest floor.

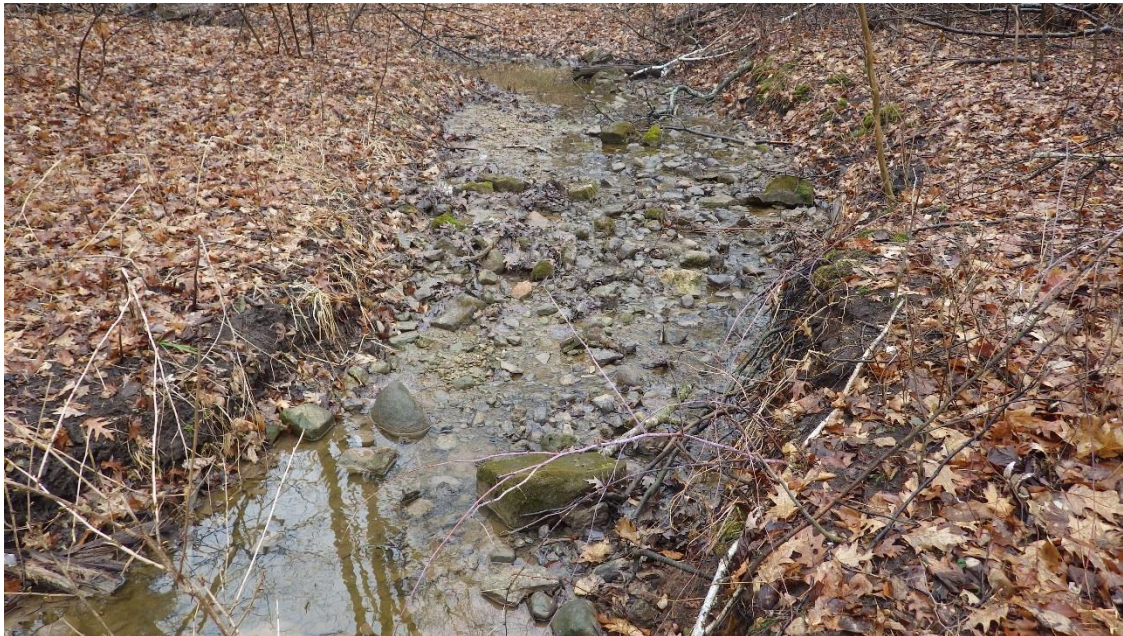
32: RIMG0041

Description: The flow pathway continued east through an area with relatively little elevation change to the unnamed tributary. Sediment deposition was observed throughout this area covering the forest floor.

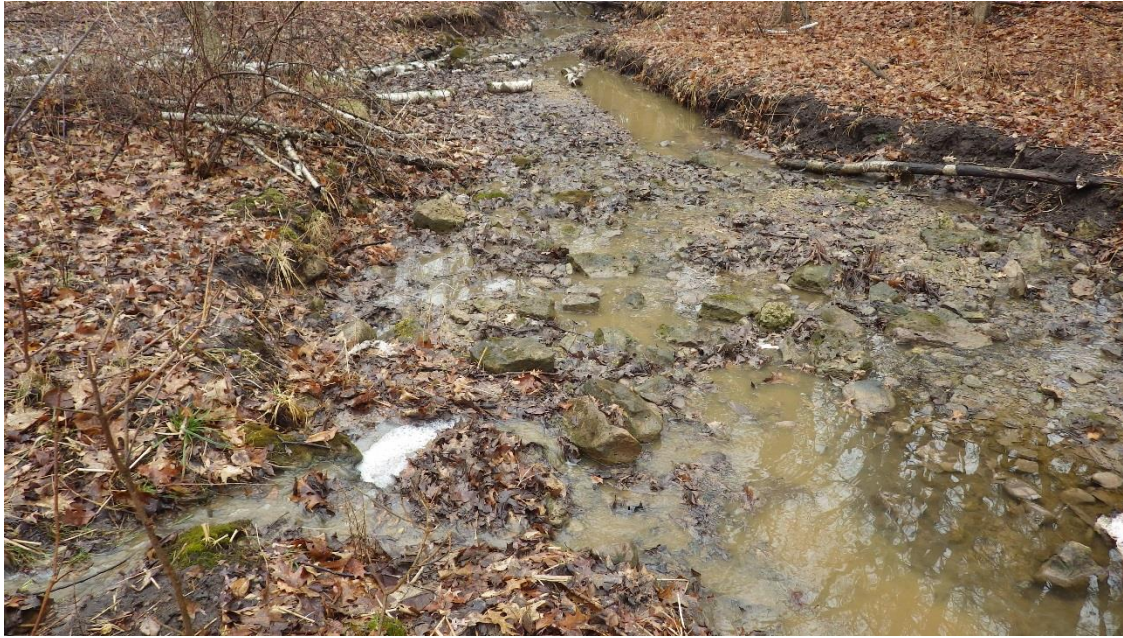
Description: The process wastewater pathway entered the unnamed tributary that abuts the east side of the Home site. The turbid water on the left hand side of the photo from the flow pathway mixed with the clear water from the upstream portion of the unnamed tributary.

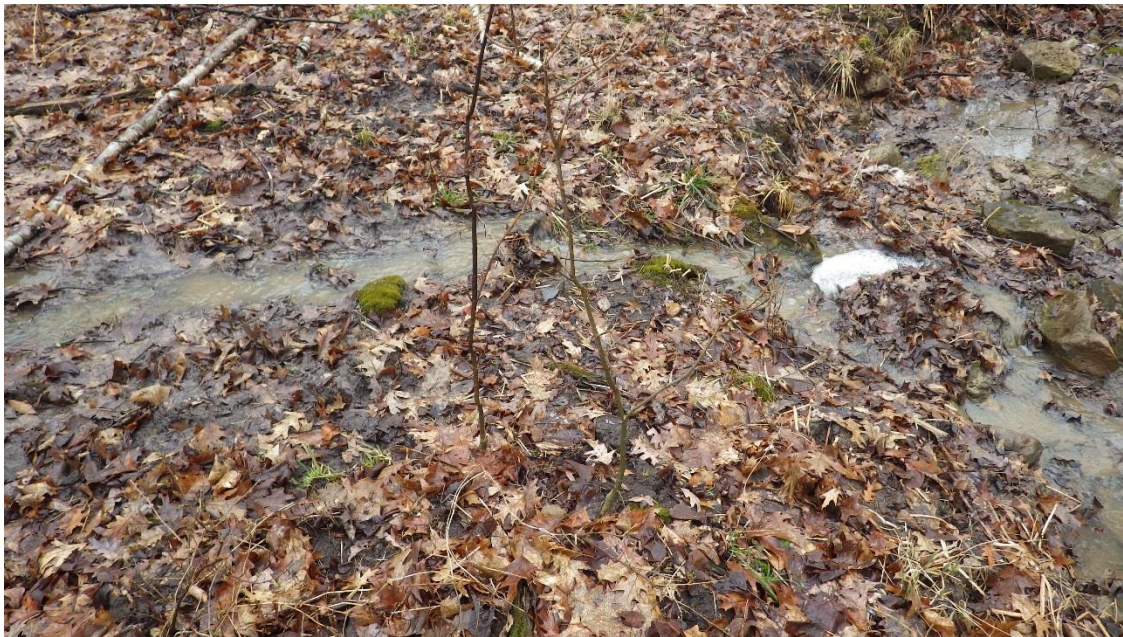
35: RIMG0044

Description: The process wastewater pathway entered the unnamed tributary that abuts the east side of the Home site. The turbid water from the flow pathway was observed throughout the downstream portion of the unnamed tributary.

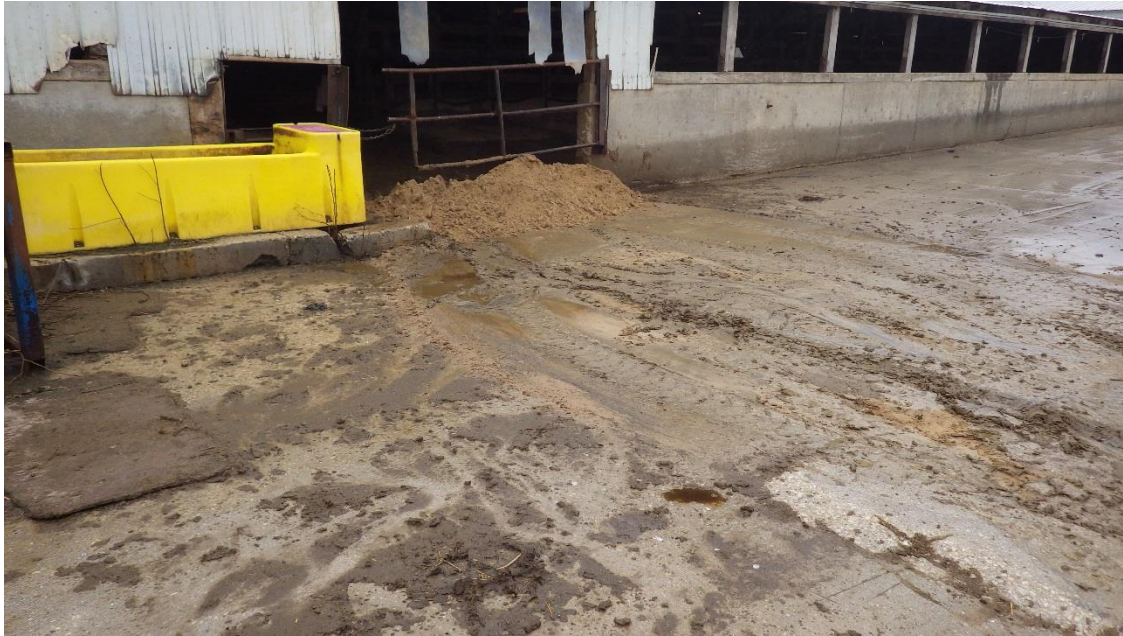
Description: Manure solids and process wastewater flowed off the concrete into the field west of the concrete pits. The manure and process wastewater was emanating from the New Barn, the barn west of the New Barn, and the access ways between these barns.

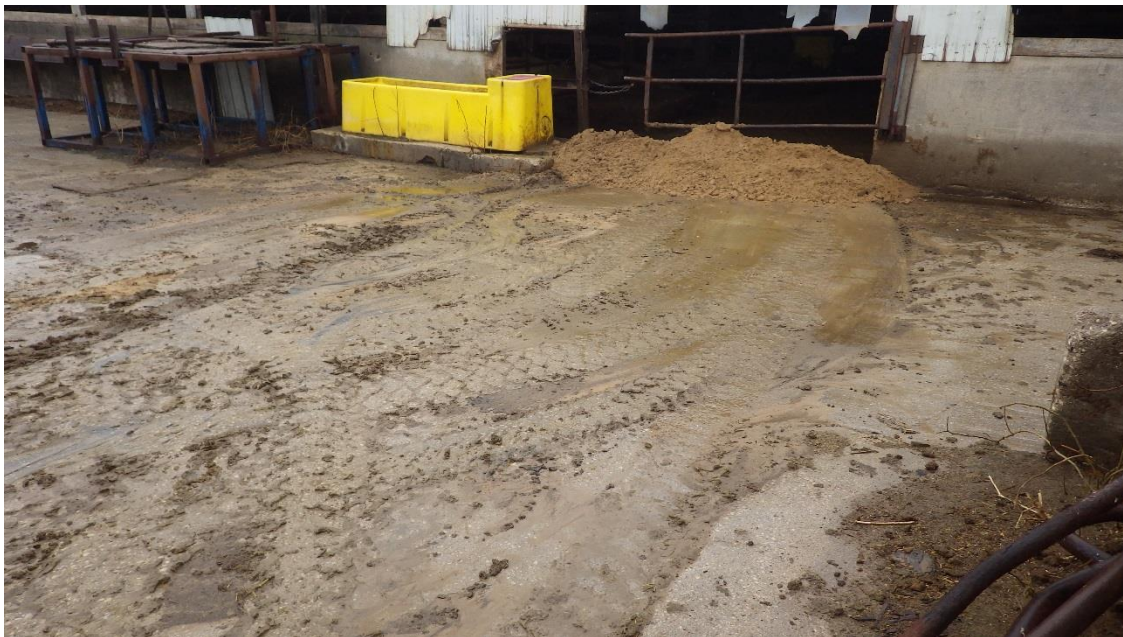
51: RIMG0060

Description: A recently placed sand berm had been place at a barn doorway. Manure and process wastewater was observed outside of the doorway on the concrete.

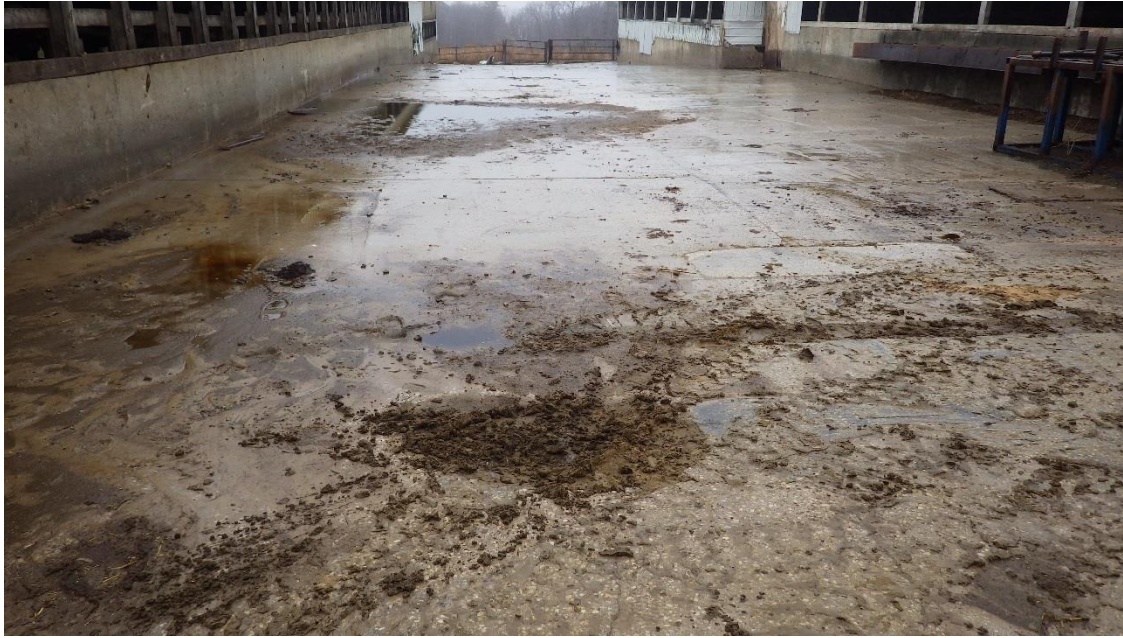
52: RIMG0061

Description: A recently placed sand berm had been place at a barn doorway. Manure and process wastewater was observed outside of the doorway on the concrete.

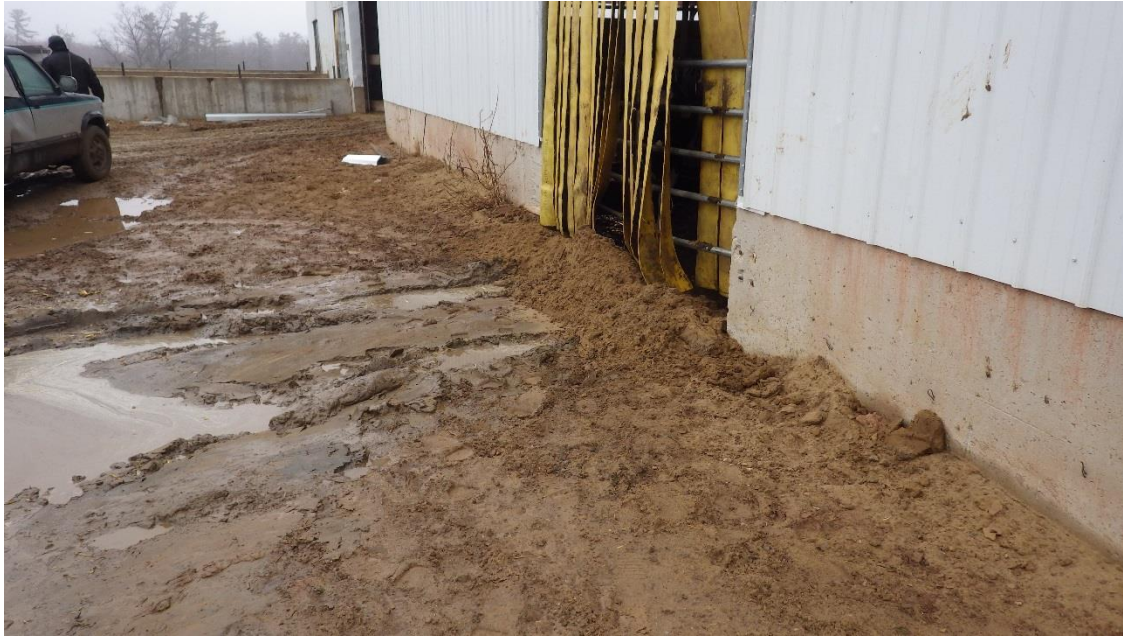
Description: A mucky area drains toward the culvert under the New Barn.

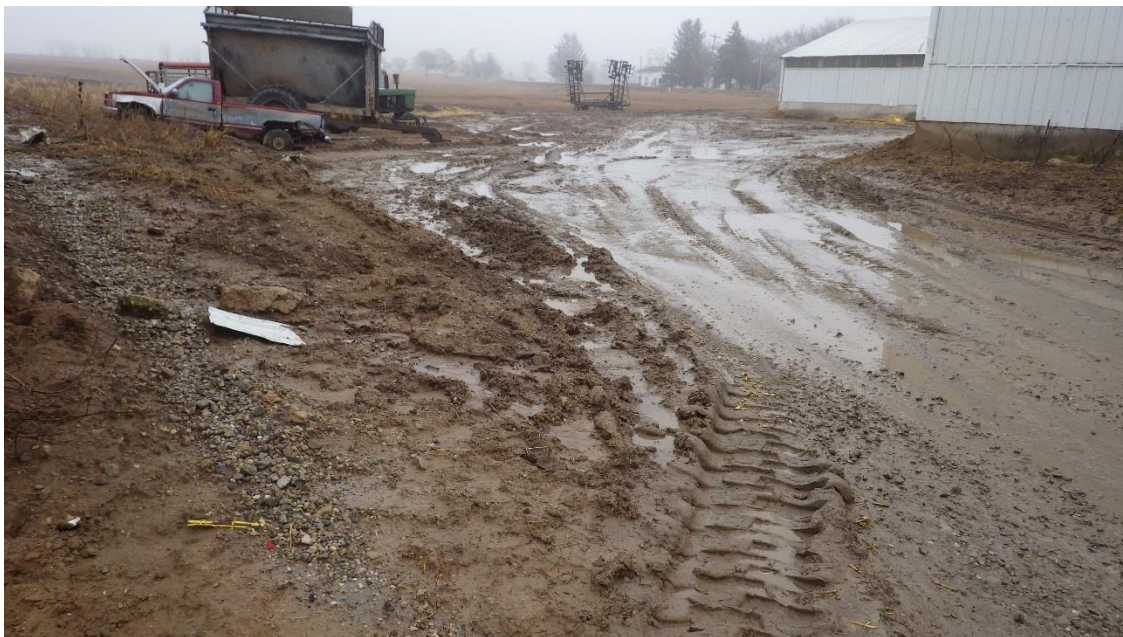
63: RIMG0072

Description: Sand had been placed at an access point along the southwest end of the New Barn. Manure and process wastewater was observed outside of the New Barn and could flow south toward the mucky area.

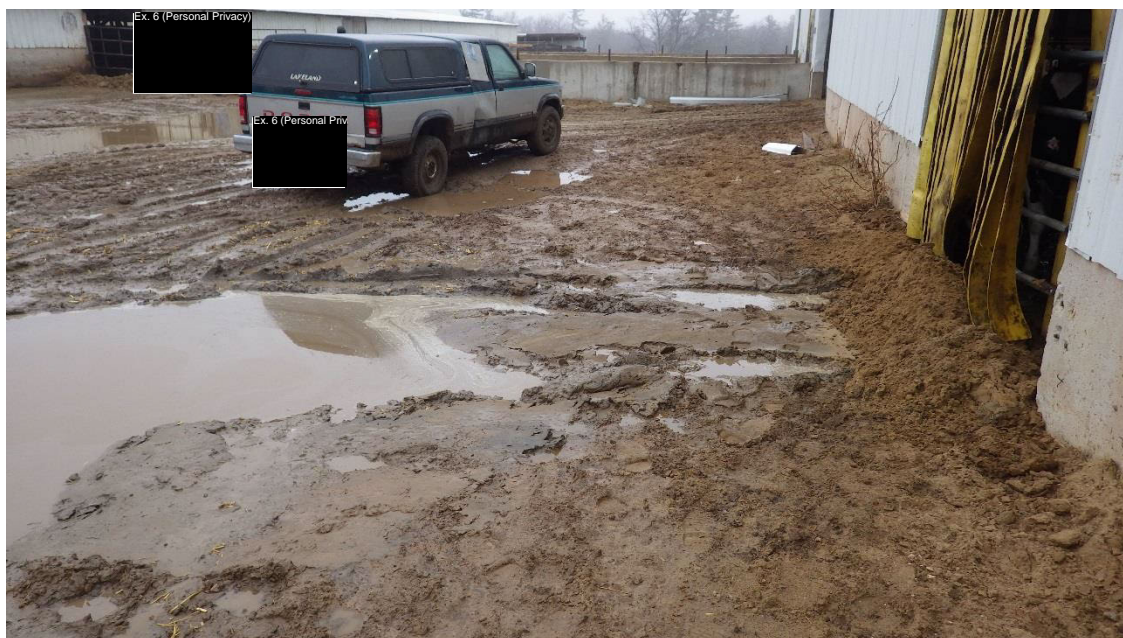
64: RIMG0073

Description: Manure and process wastewater was observed outside of the New Barn and could flow south toward the mucky area.

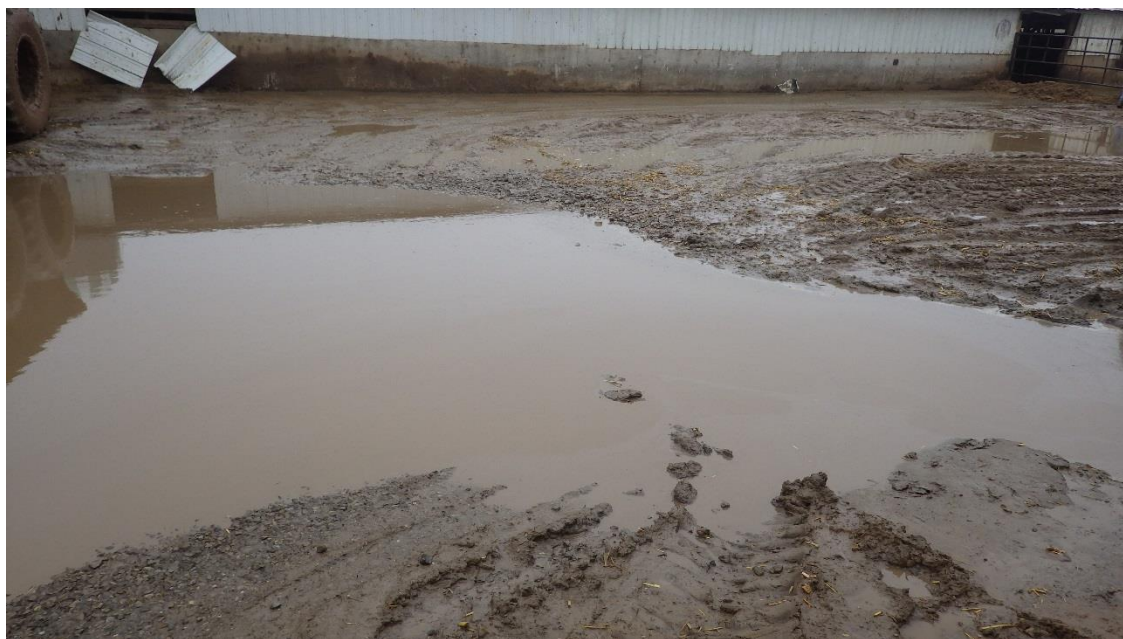
65: RIMG0074

Description: Sand had been placed at an access point along the west end of the New Barn. Manure and process wastewater was observed outside of the New Barn and could flow south toward the mucky area.

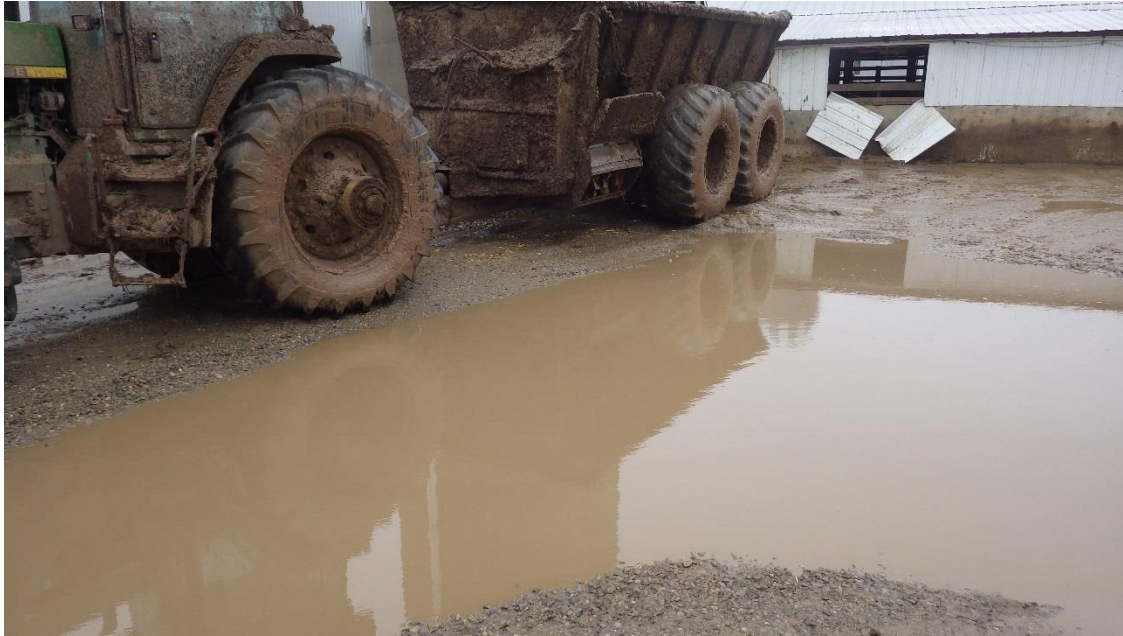
66: RIMG0075

Description: Manure and process wastewater was observed outside of the New Barn and could flow south toward the mucky area.

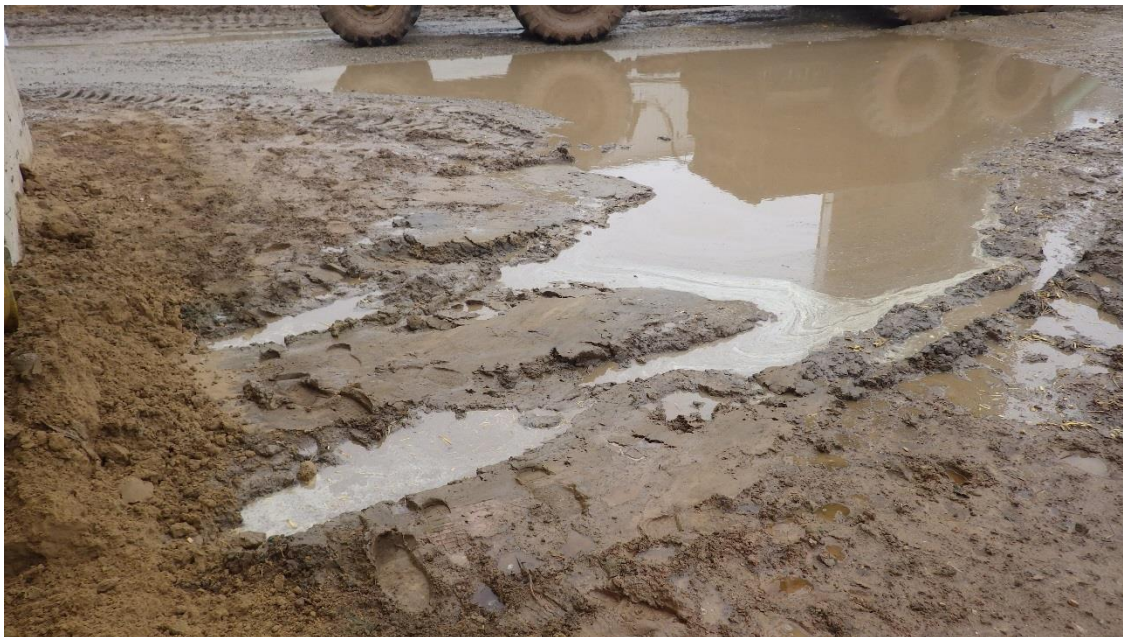
67: RIMG0076

Description: Manure and process wastewater was observed outside of the New Barn and could flow south toward the mucky area.

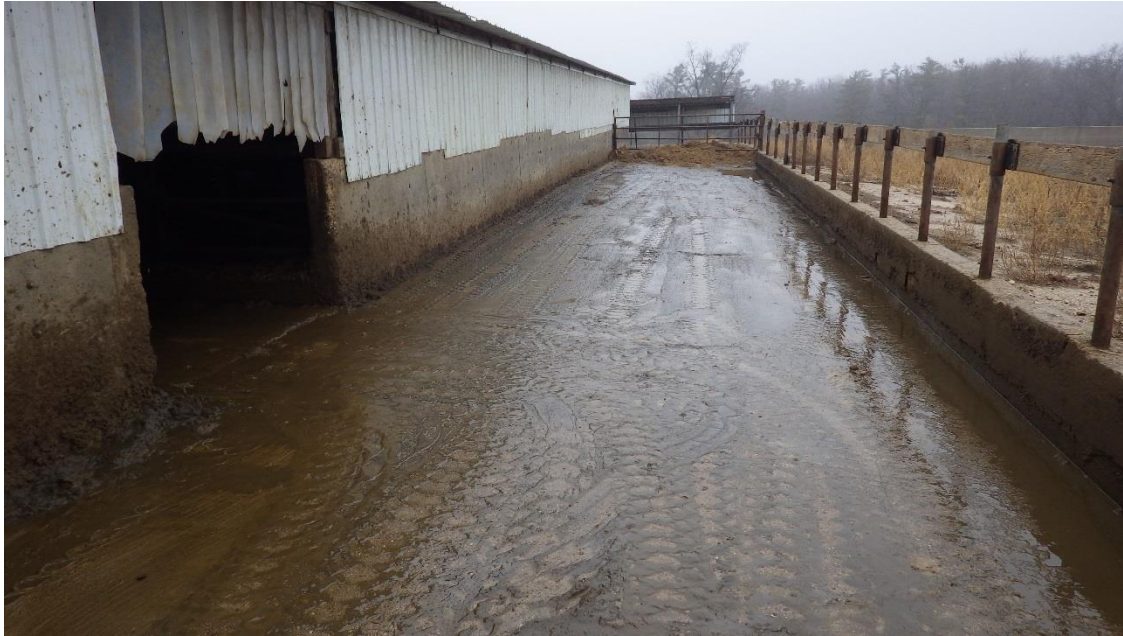
68: RIMG0077

Description: Sand had been placed at an access point along the west end of the New Barn. Manure and process wastewater was observed outside of the New Barn and could flow south toward the mucky area.

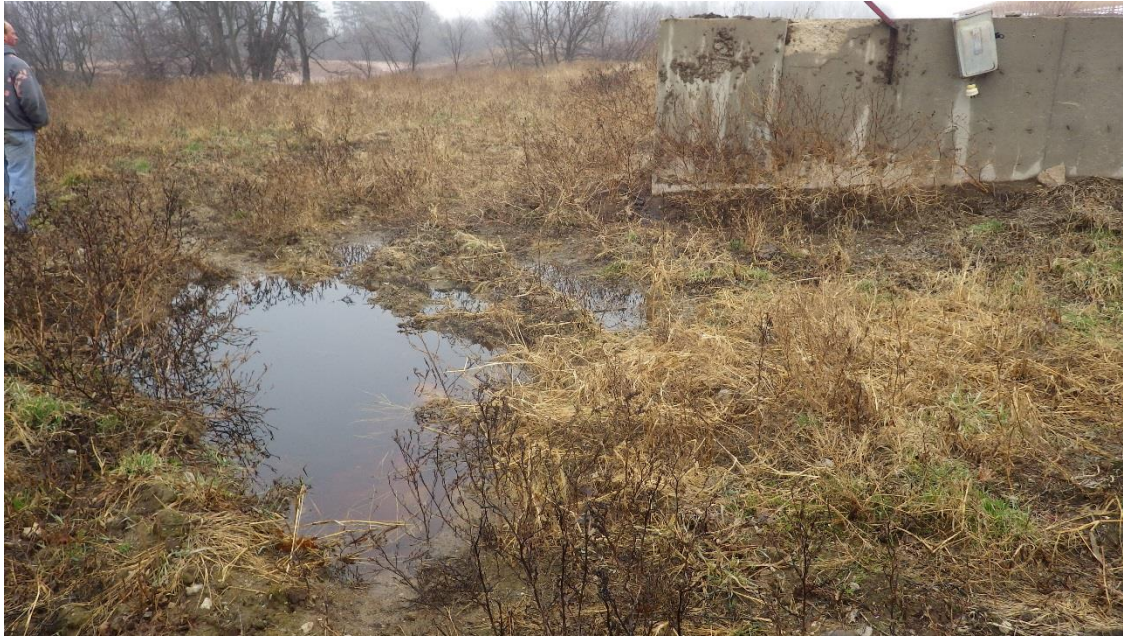
Description: The west concrete pit was about halfway full.

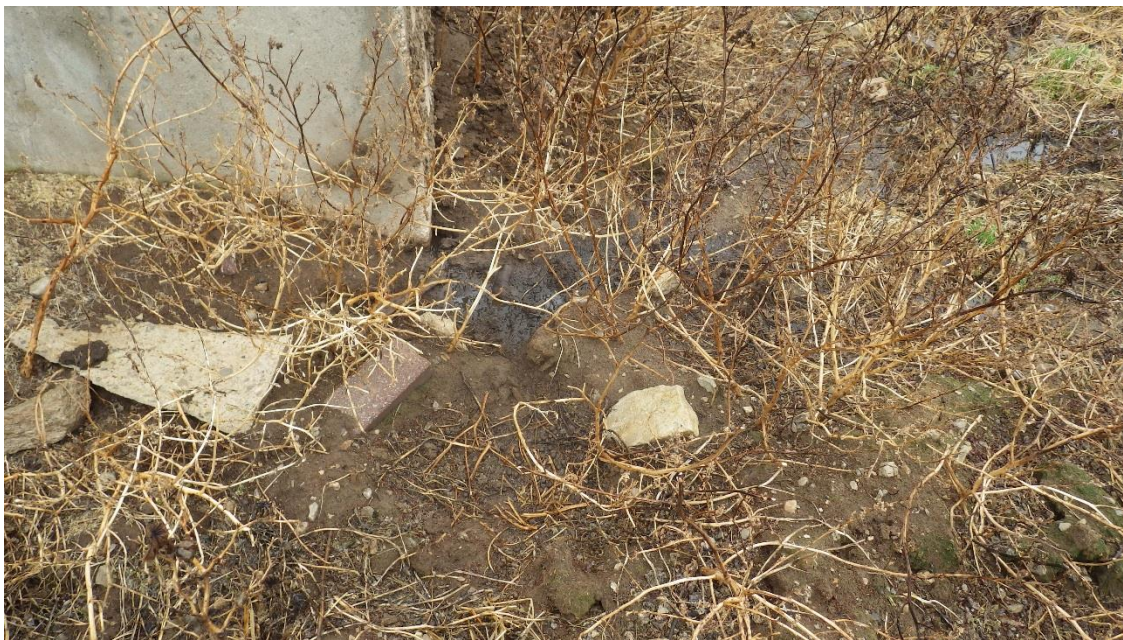
75: RIMG0084

1. At the Home site, process wastewater was trickling out of the northwest corner of the concrete pit and was observed in a depressional area. The depressional area drained north through pathways and was observed discharging to the unnamed tributary on the east side of the Home site.

Description: Process wastewater was observed at the northwest corner of the west concrete pit.

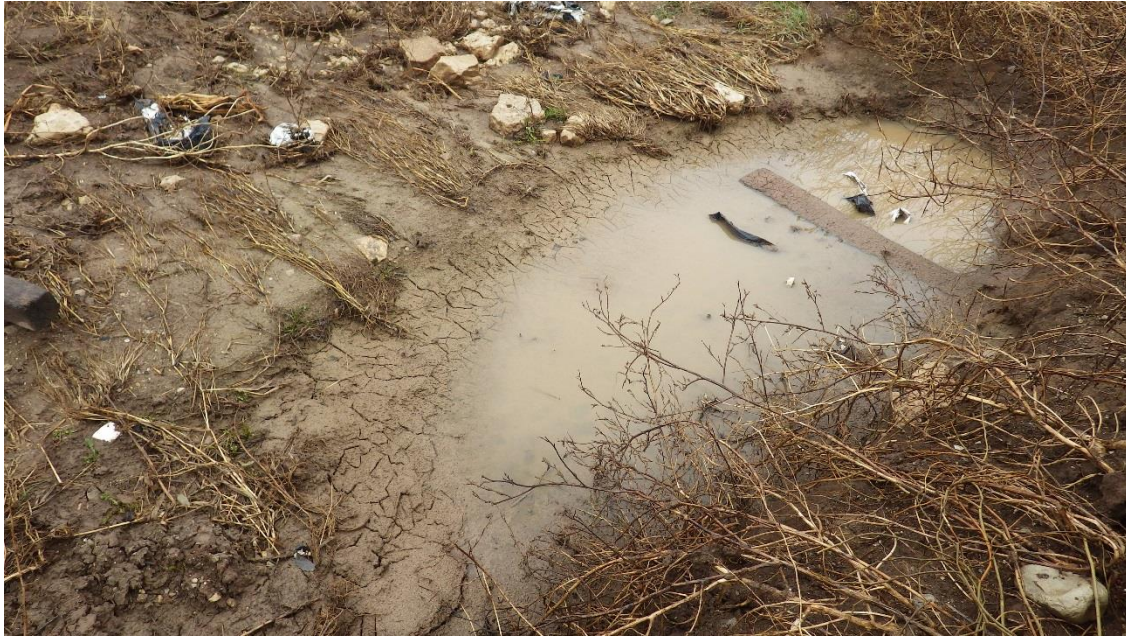
78: RIMG0087

Description: The north east end of the east concrete pit had clay covering a hole that was observed in the east concrete pit in an April 2013 inspection.

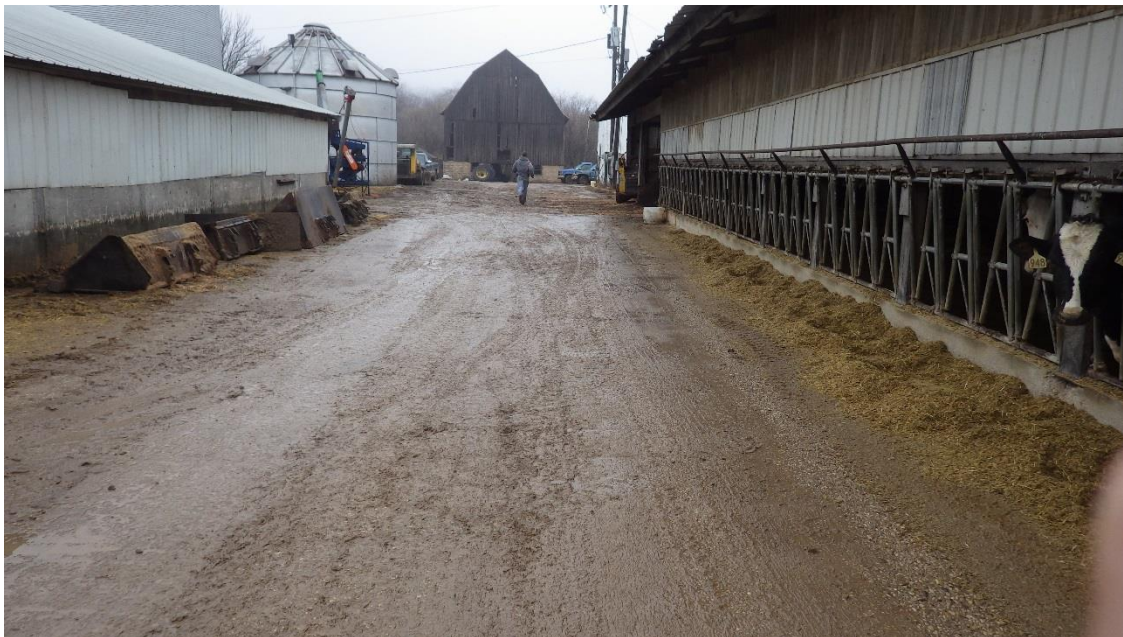
Description: Manure and process wastewater flowed from the New Barn and access way west and then north.
